UNITED STATES DEPARTMENT OF THE INTERIOR AVIATION MANAGEMENT

Safety Alert

No. 05-02

Subject: External Cargo Net/Sling Load Equipment

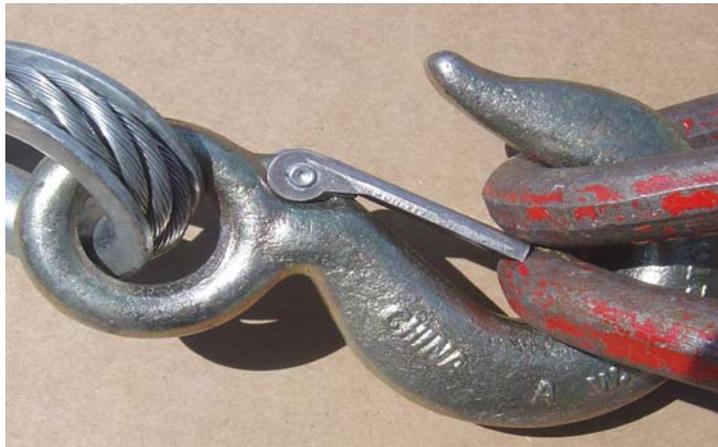
The two rings of most cargo nets will not fit on the new smaller J-hooks of the lead lines because the spring loaded keeper gate is too long to allow the two rings to be attached to the hook (see illustration). If the rings are forced onto the hook, the keeper gate can be bent or possibly broken creating an unsafe condition by allowing one or both rings to accidentally slide off the hook during load operations.

There are no manufacturer's markings to identify the problem keeper gates and the only distinguishing features are that the keeper gate is riveted to the hook and is approximately 3/8 of an inch longer than the traditional keeper gate. San Dimas Technology and Development Center is aware of the problem and is currently working on a corrective solution. In the interim, inventory and check assigned sling gear and set aside any hooks that have this particular gate.
